TECHNICAL INSPECTION REPORT

OPERATION CROSSROADS. U.S.S. INDEPENDENCE (CVL 22)

TEST ABLE.

VOLUME 2 OF 4 [10]

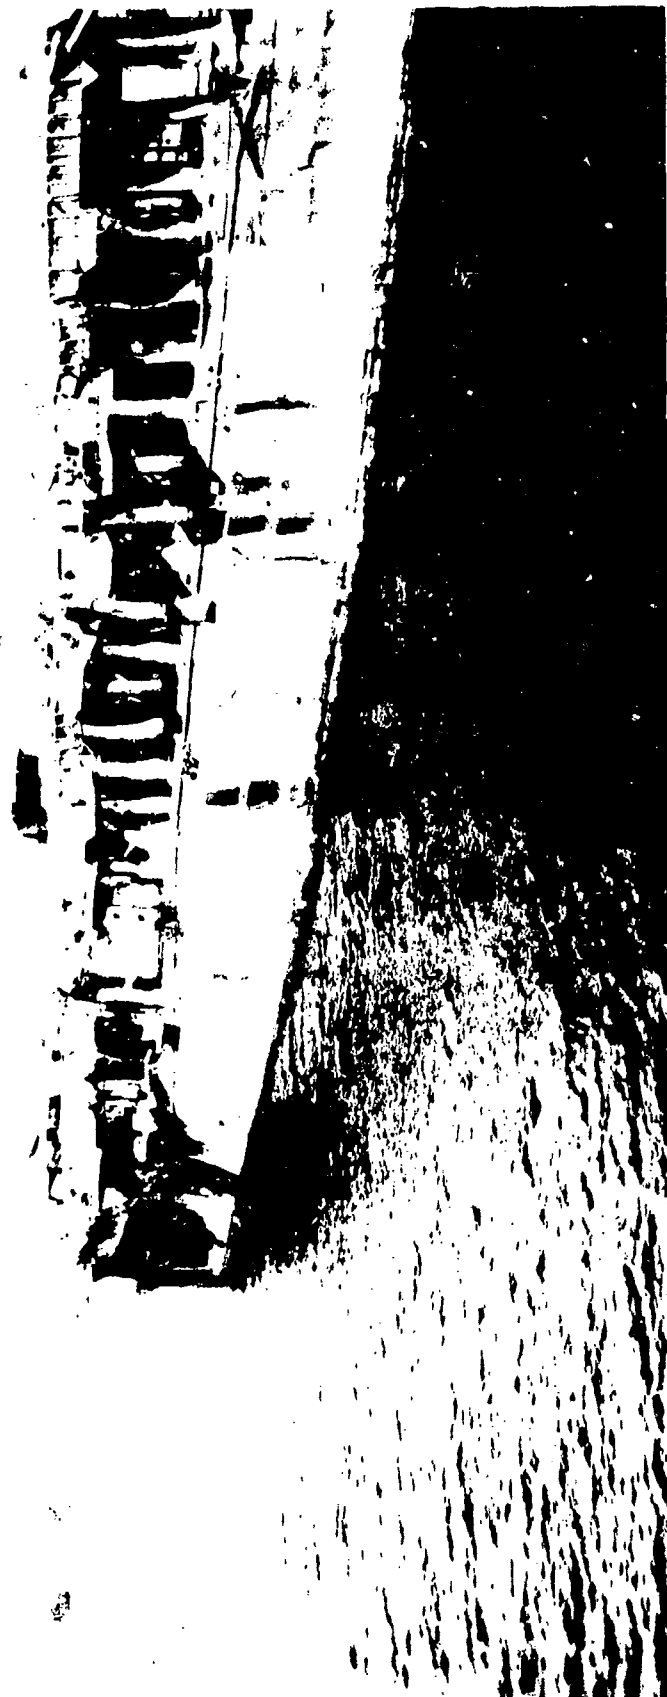
AB-CR-221-353-20. Damage to port shell and hangar cover plating, looking forward and to starboard, from off port quarter. Note washboarding of shell plating between frames.

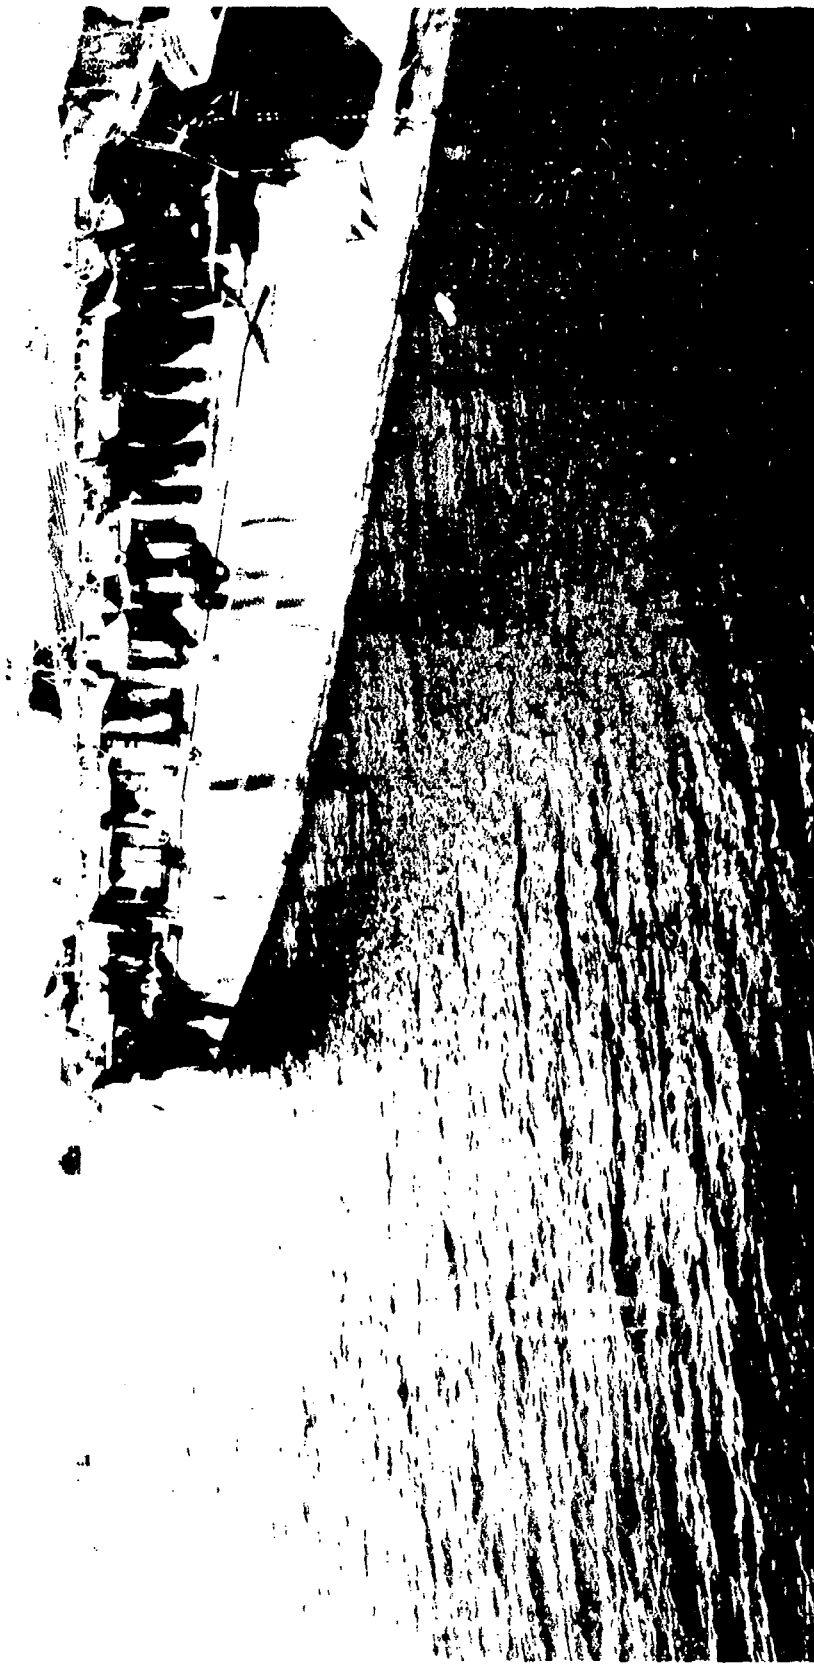
AB-CR-221-353-19. Damage to port shell and hangar cover plating, "looking forward and to starboard, from off port quarter."

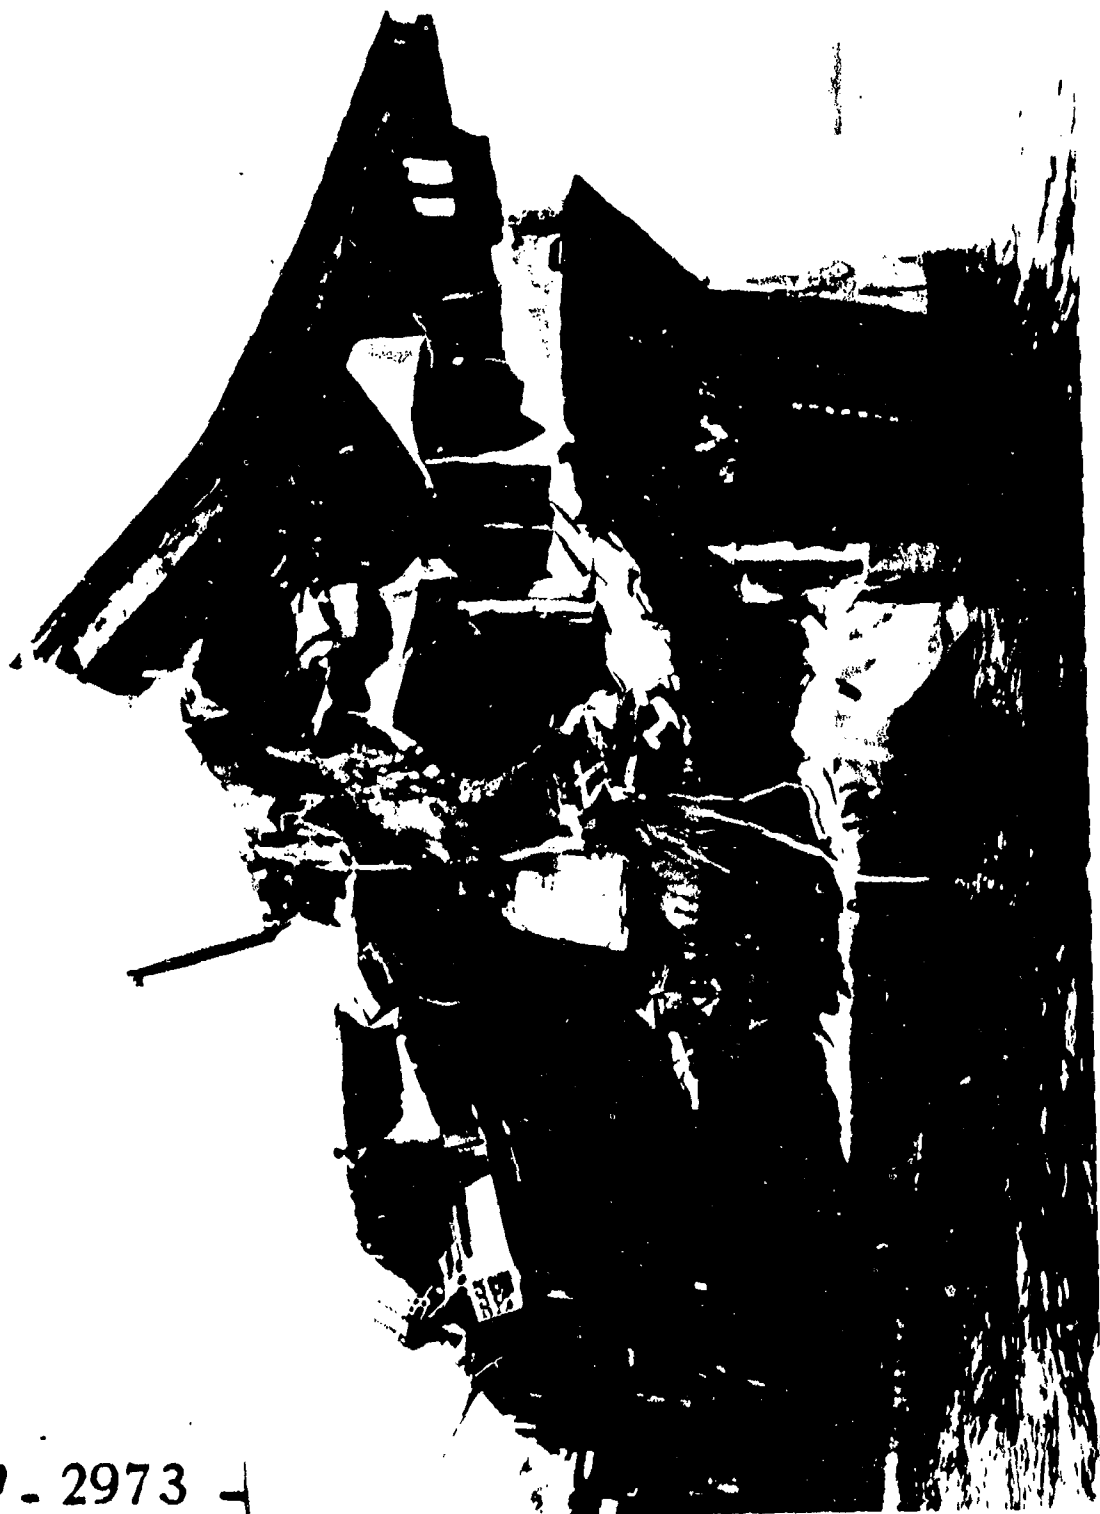
AB CR 79 - 2973 -

AB-CR-79-2973-2. After Baker. View of port quarter.

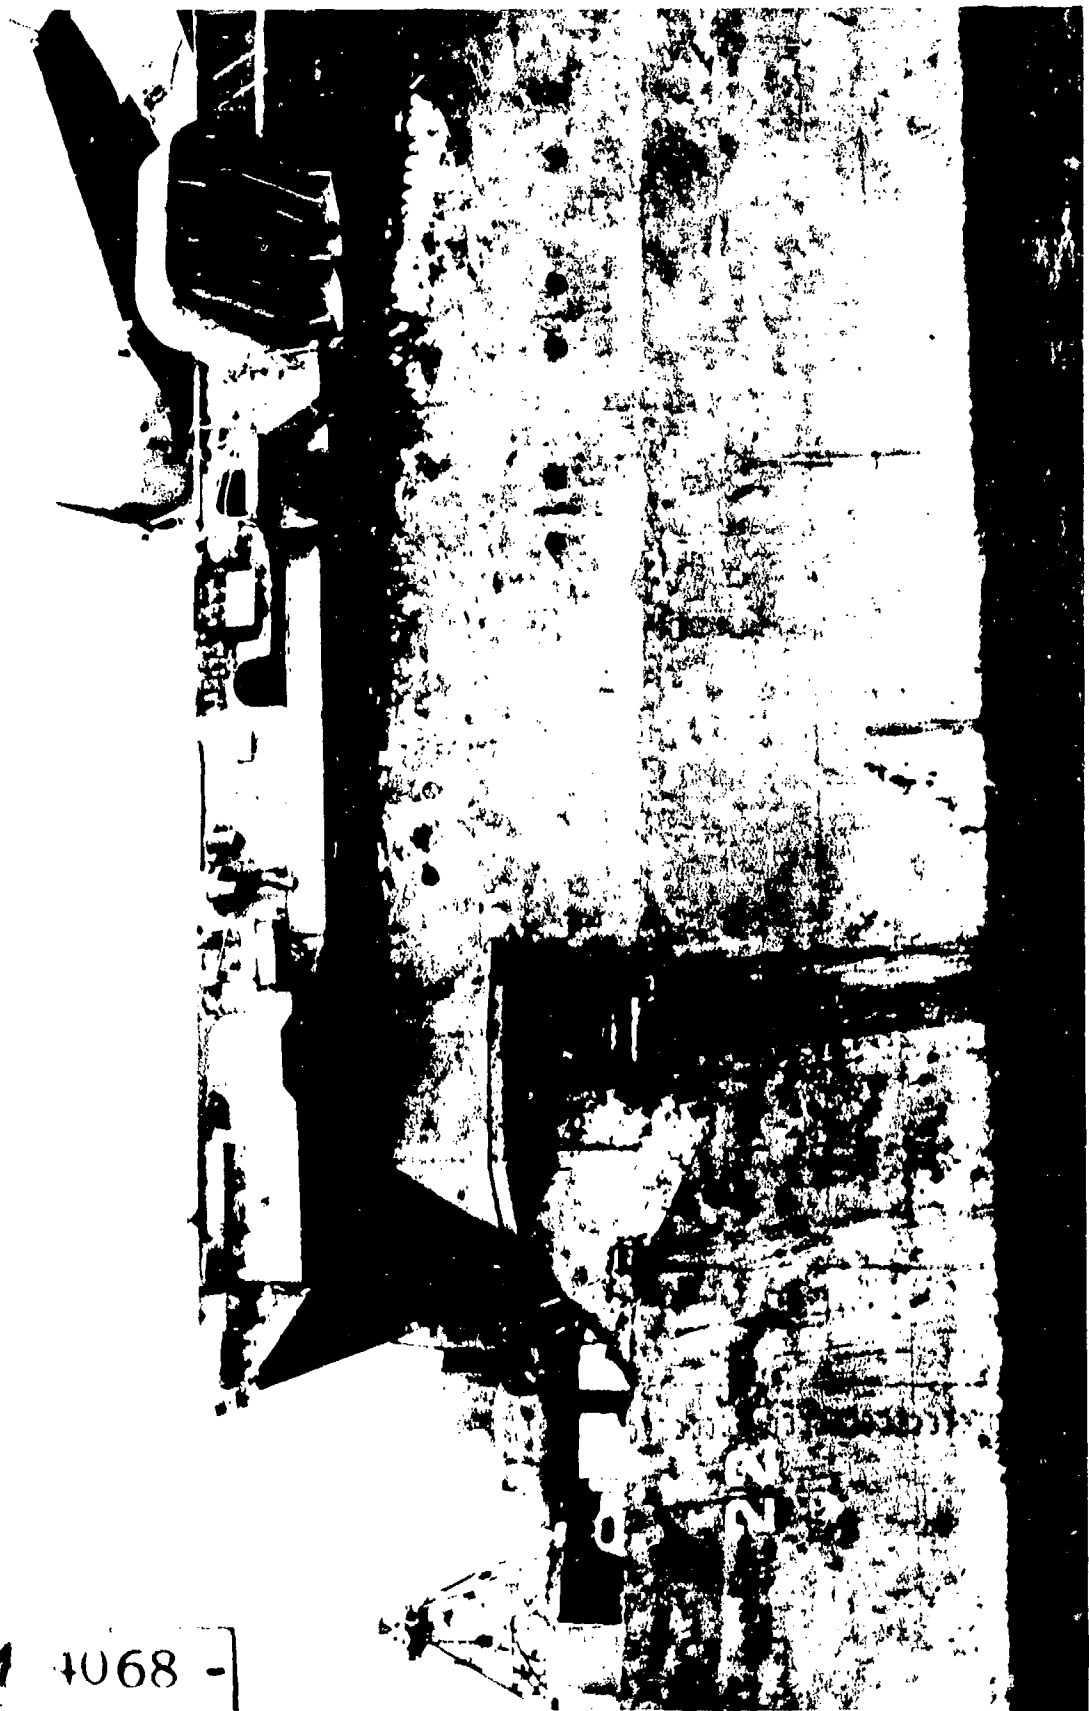
AB-CR-79-4068-5

AB-CR-79-4068-5. After Baker. Port shell, frame 7 to 33.

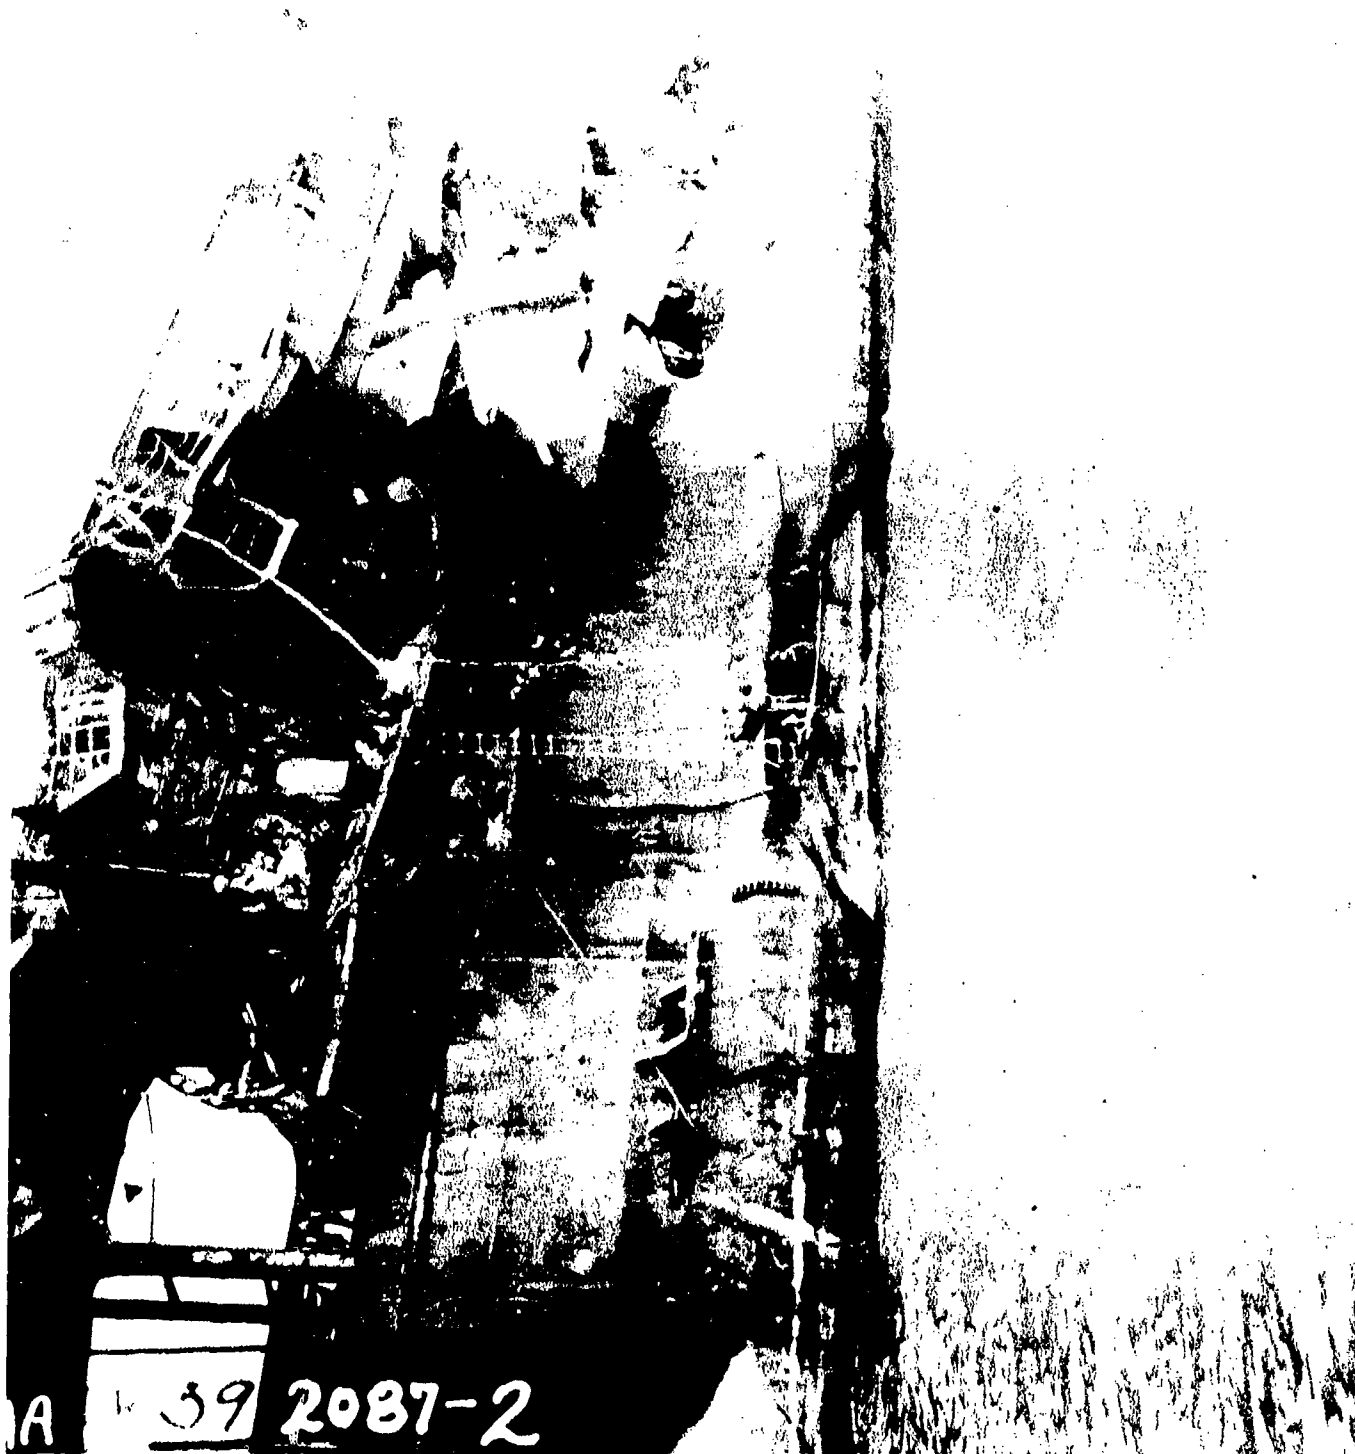
AA-CR-59-2087-2. General view of damage to port quarter, frames 118 to 146.

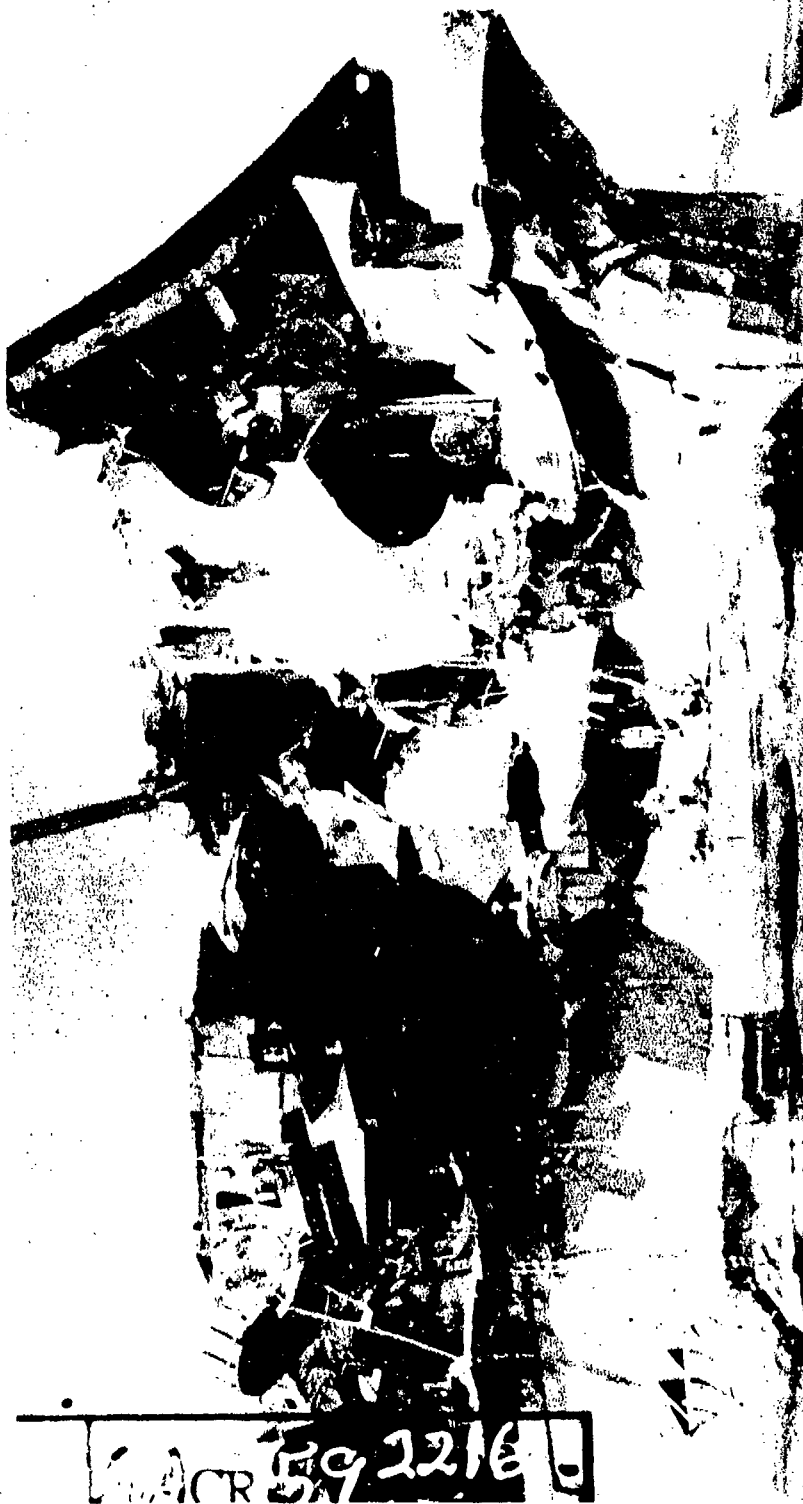
AA-CR-59-2216-1. Port quarter, frame 118 to stern.

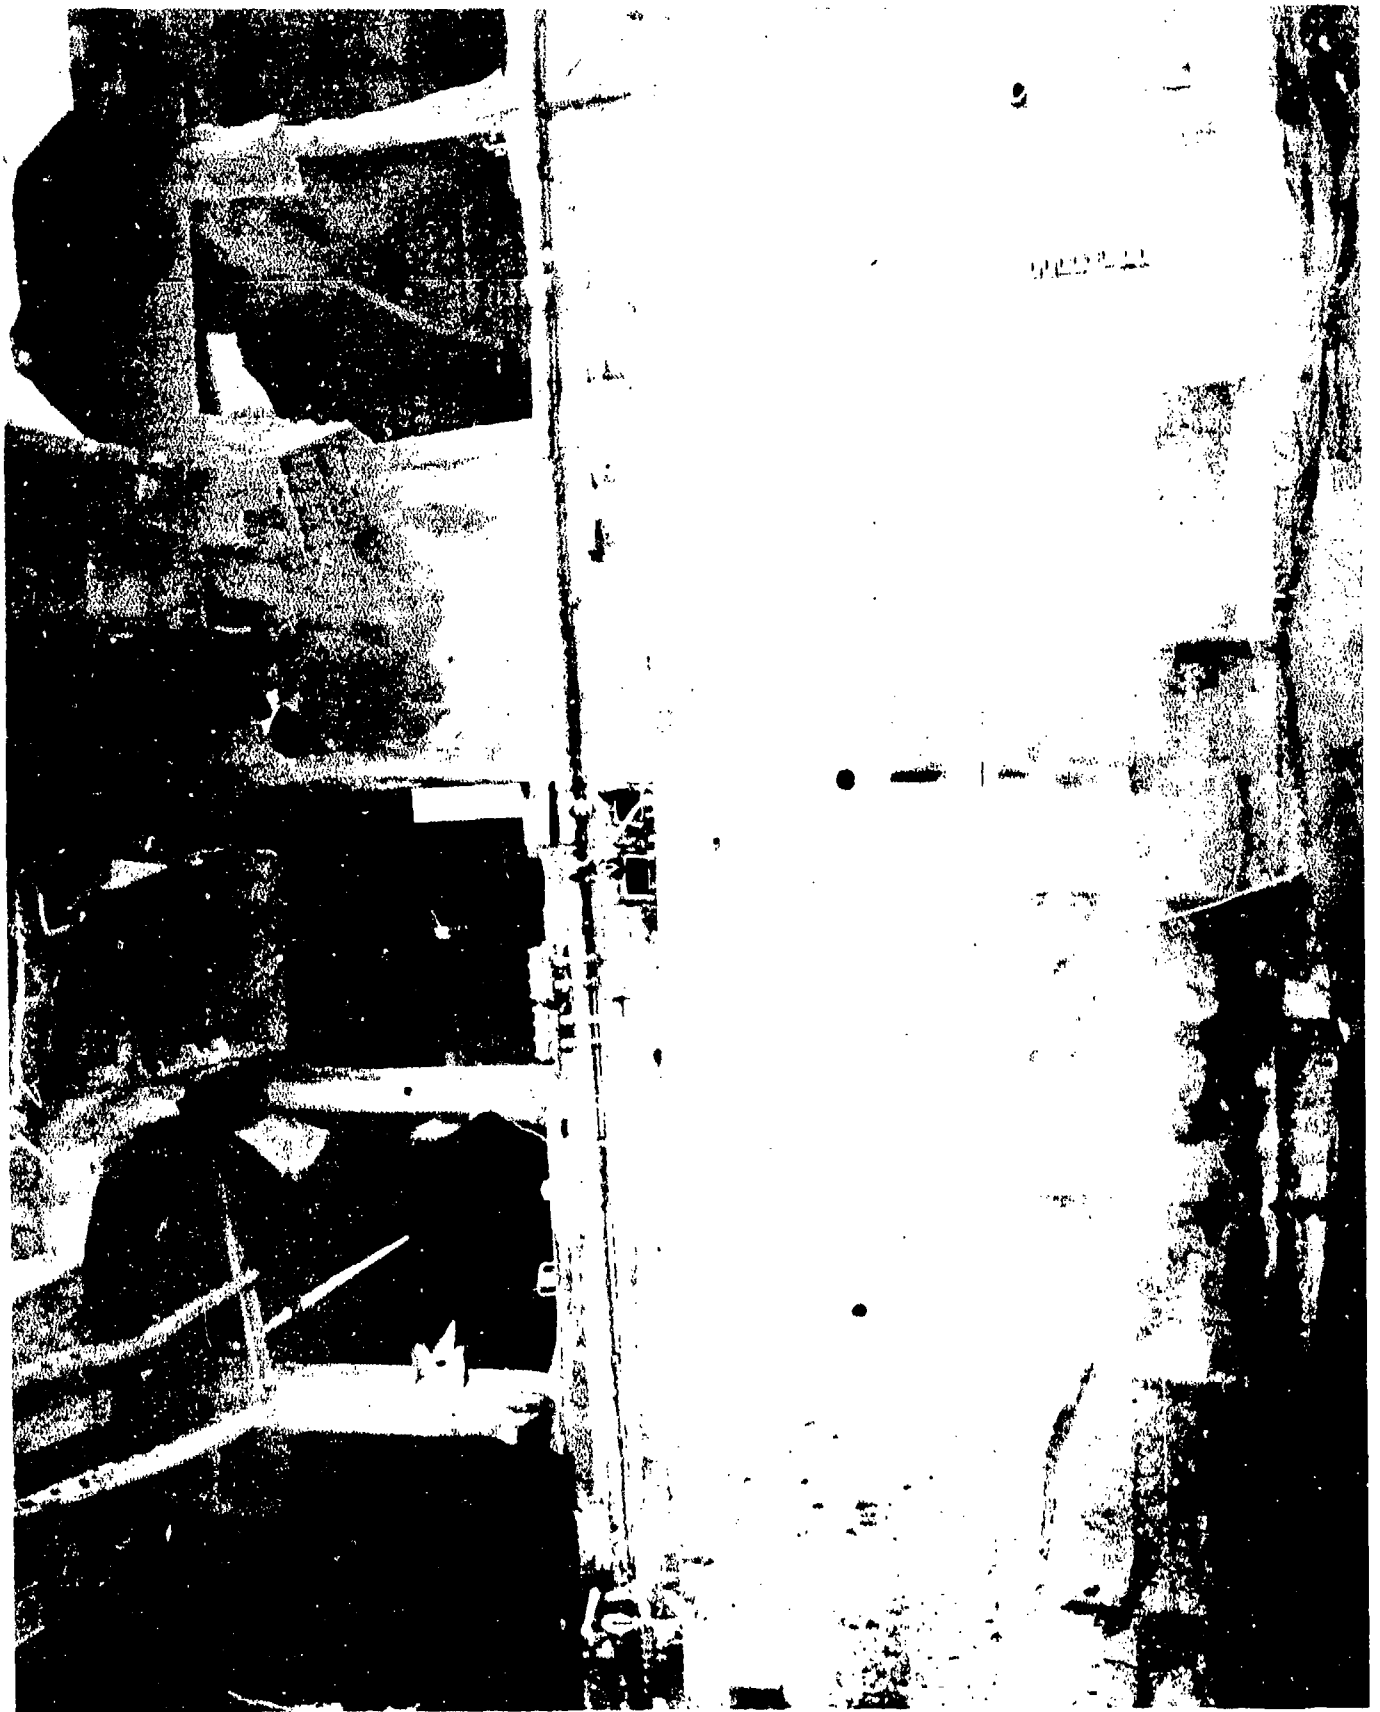
AA-CR-71-2072-12. Port shell frames 62 to 78, showing wrinkled and dished blister plating.

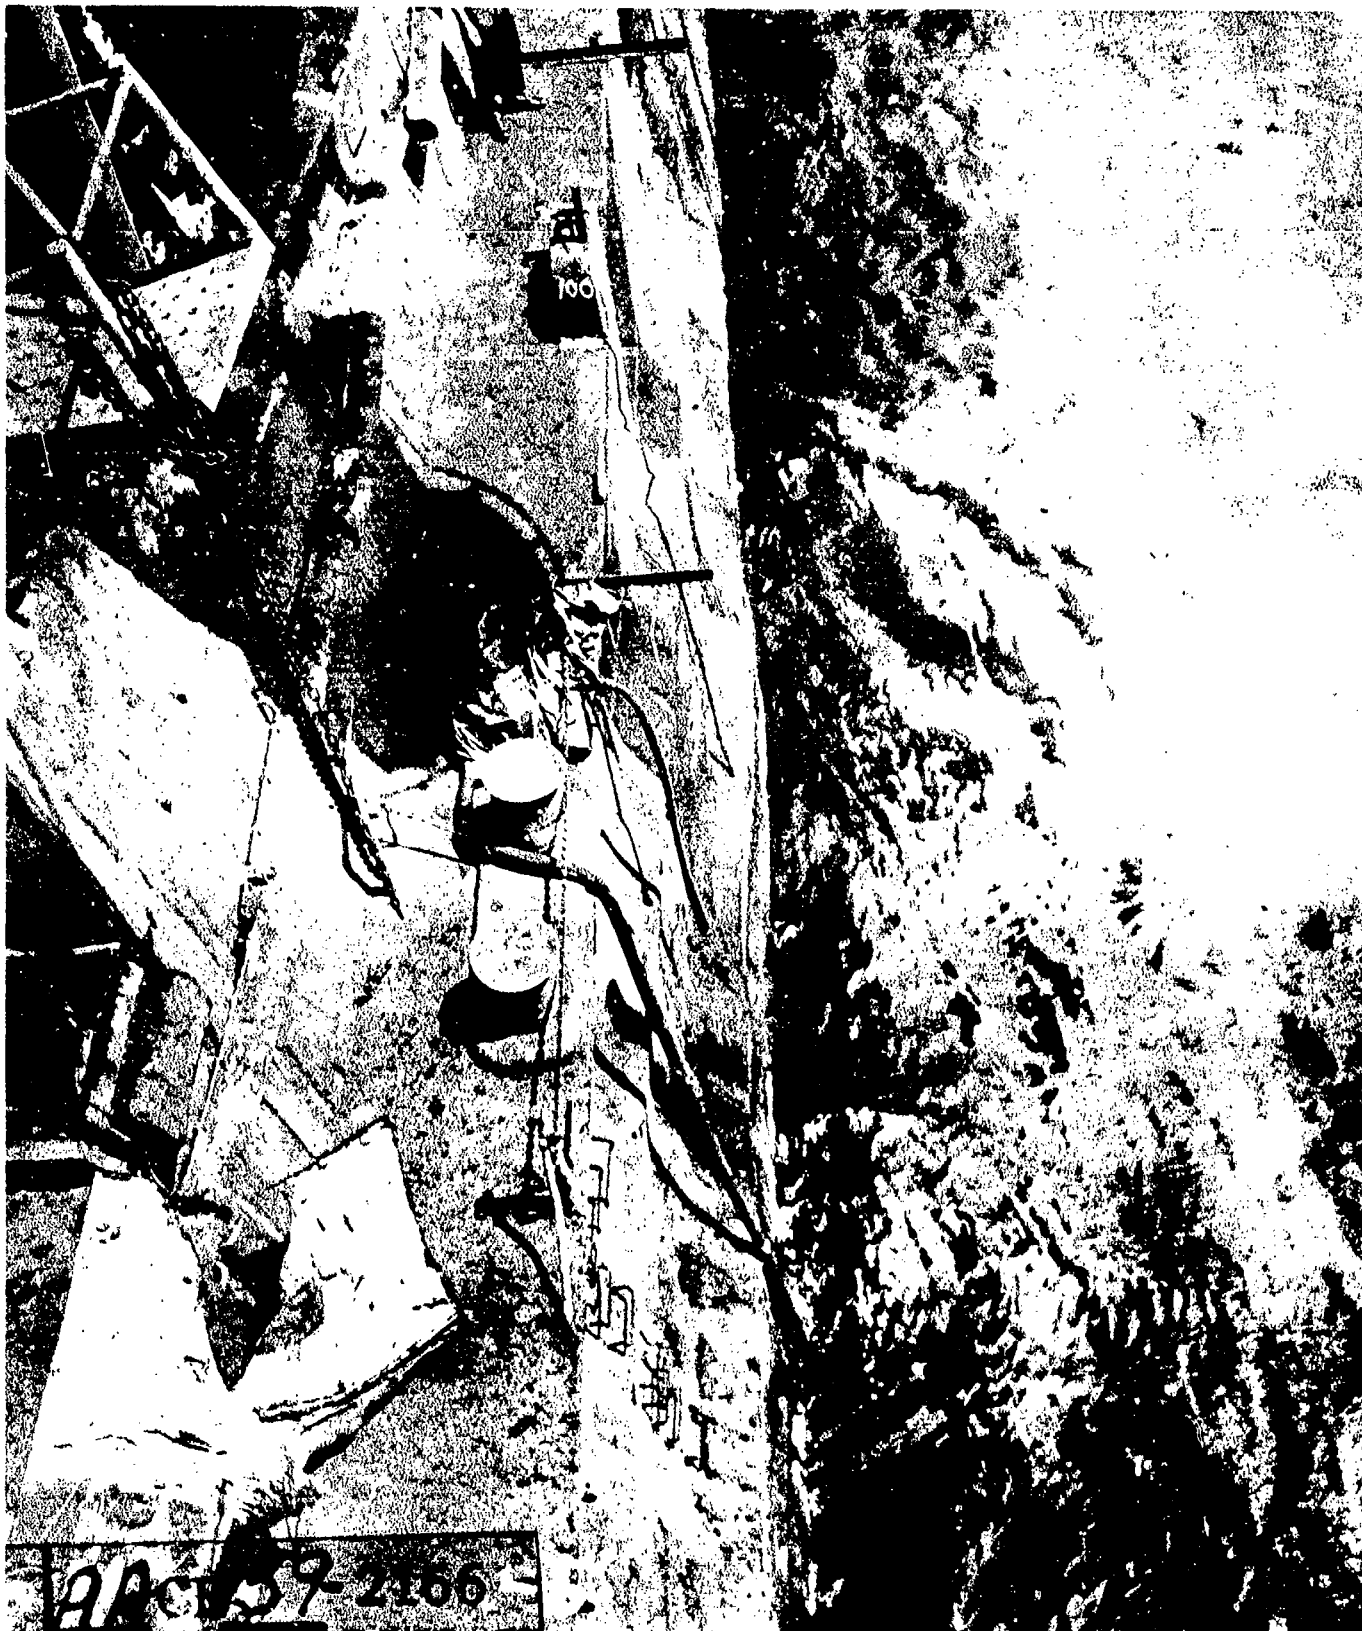
AA-CR-59-2166-6. General view of damage along port side between frames 92 and 101. Note dishing of blister shell under hose between frames 96 and 97.

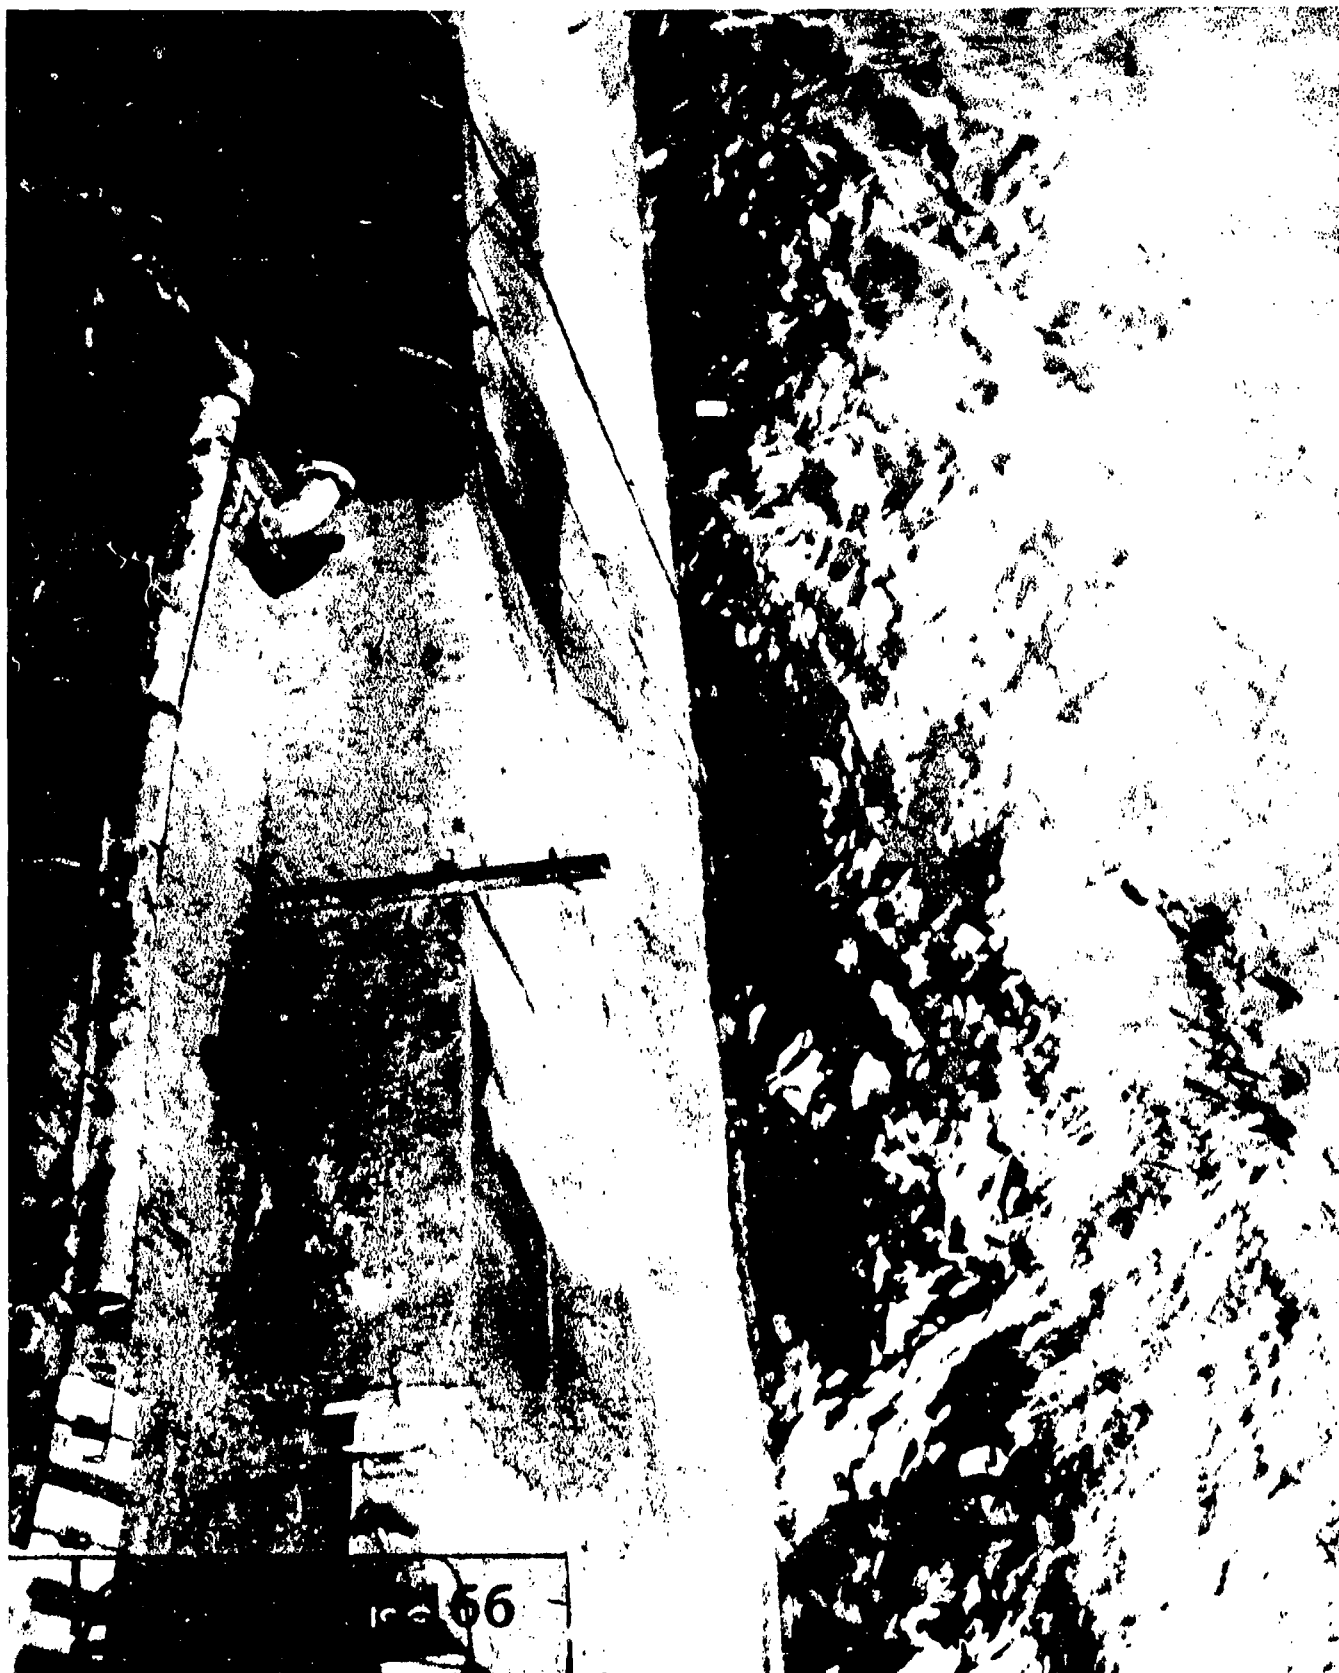
AA-CR-59-2166-7. View of blister-top and shell-port side-between frames 100 and 106. Measured deflections in shell at frame 104 were 9'' and 14'' maximum.

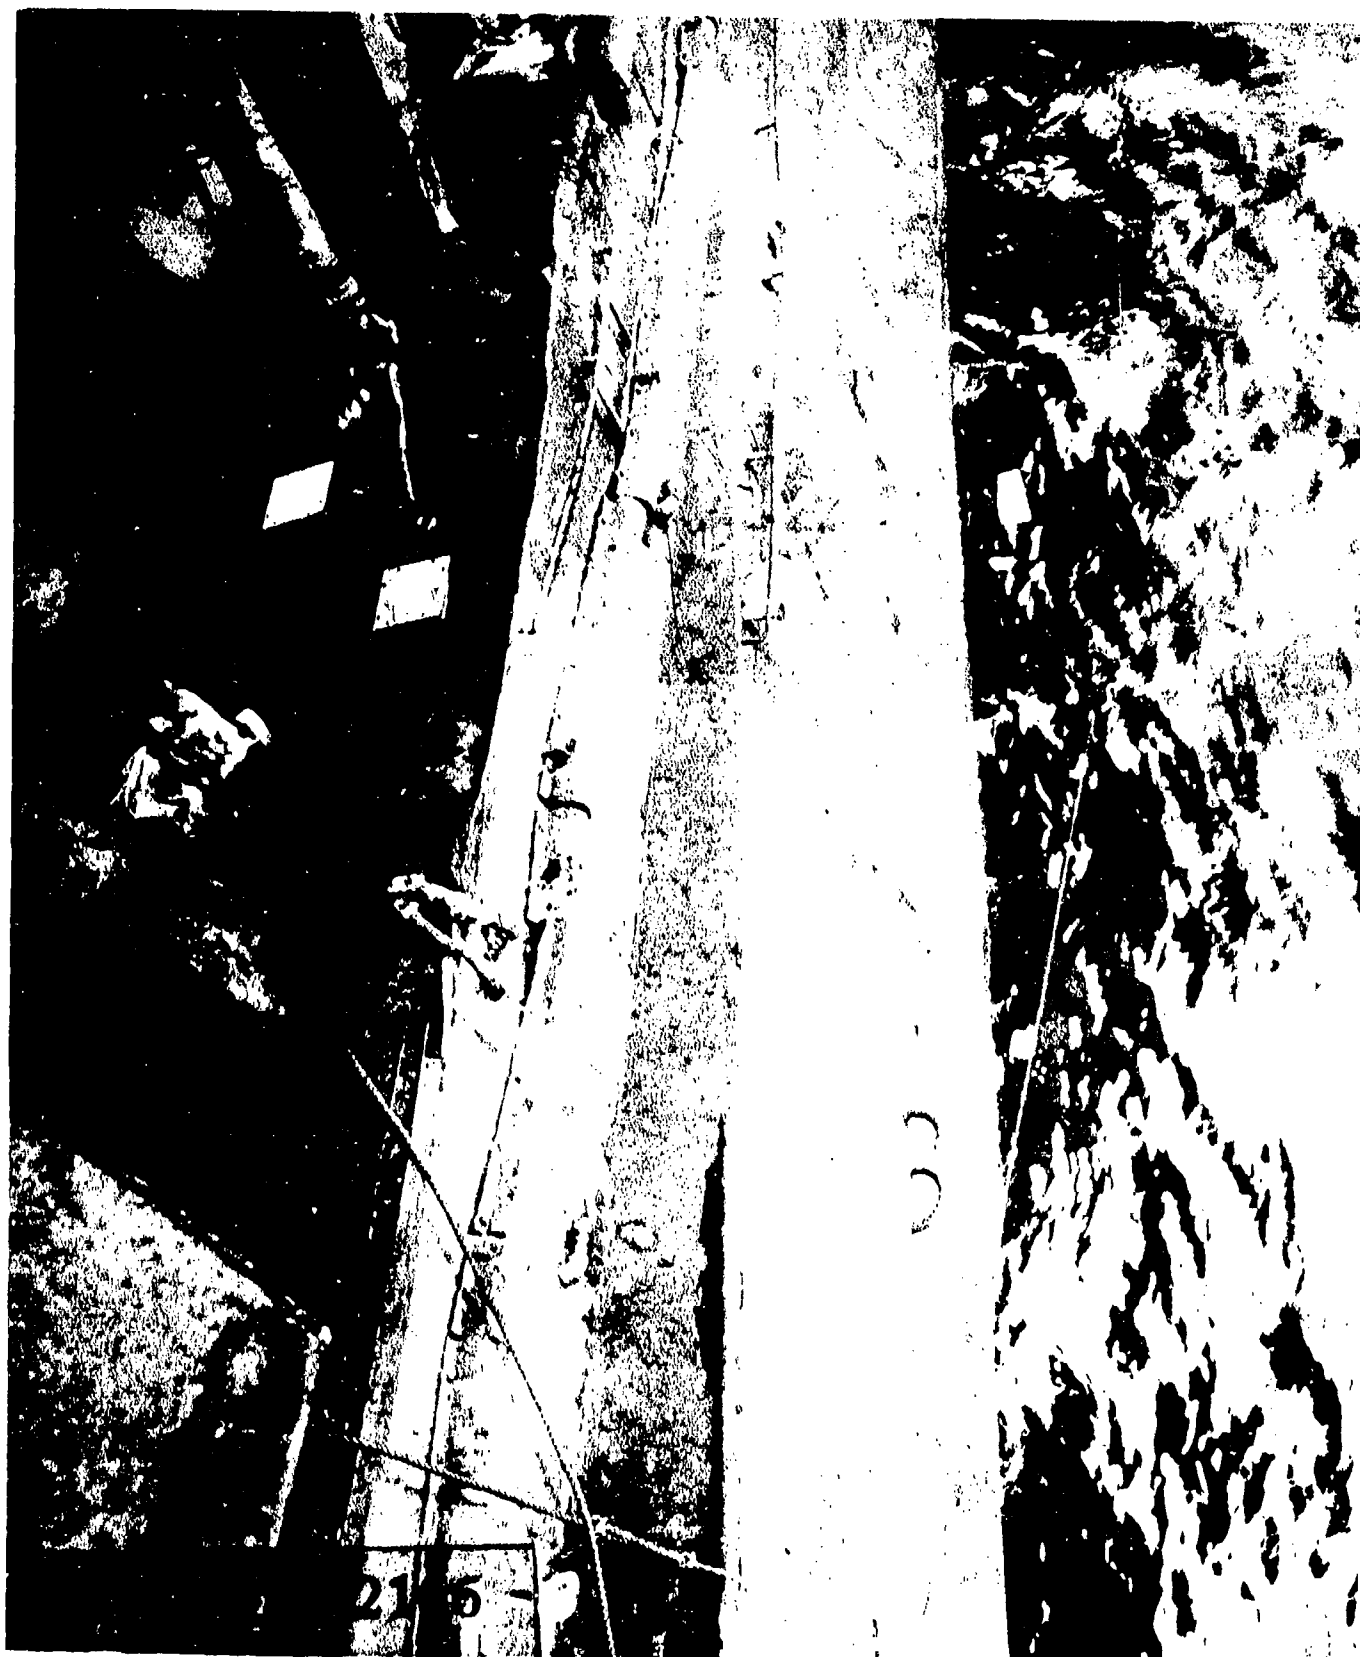
AA-CR-59-2166-8. General view between frames 108 and 120 port side.

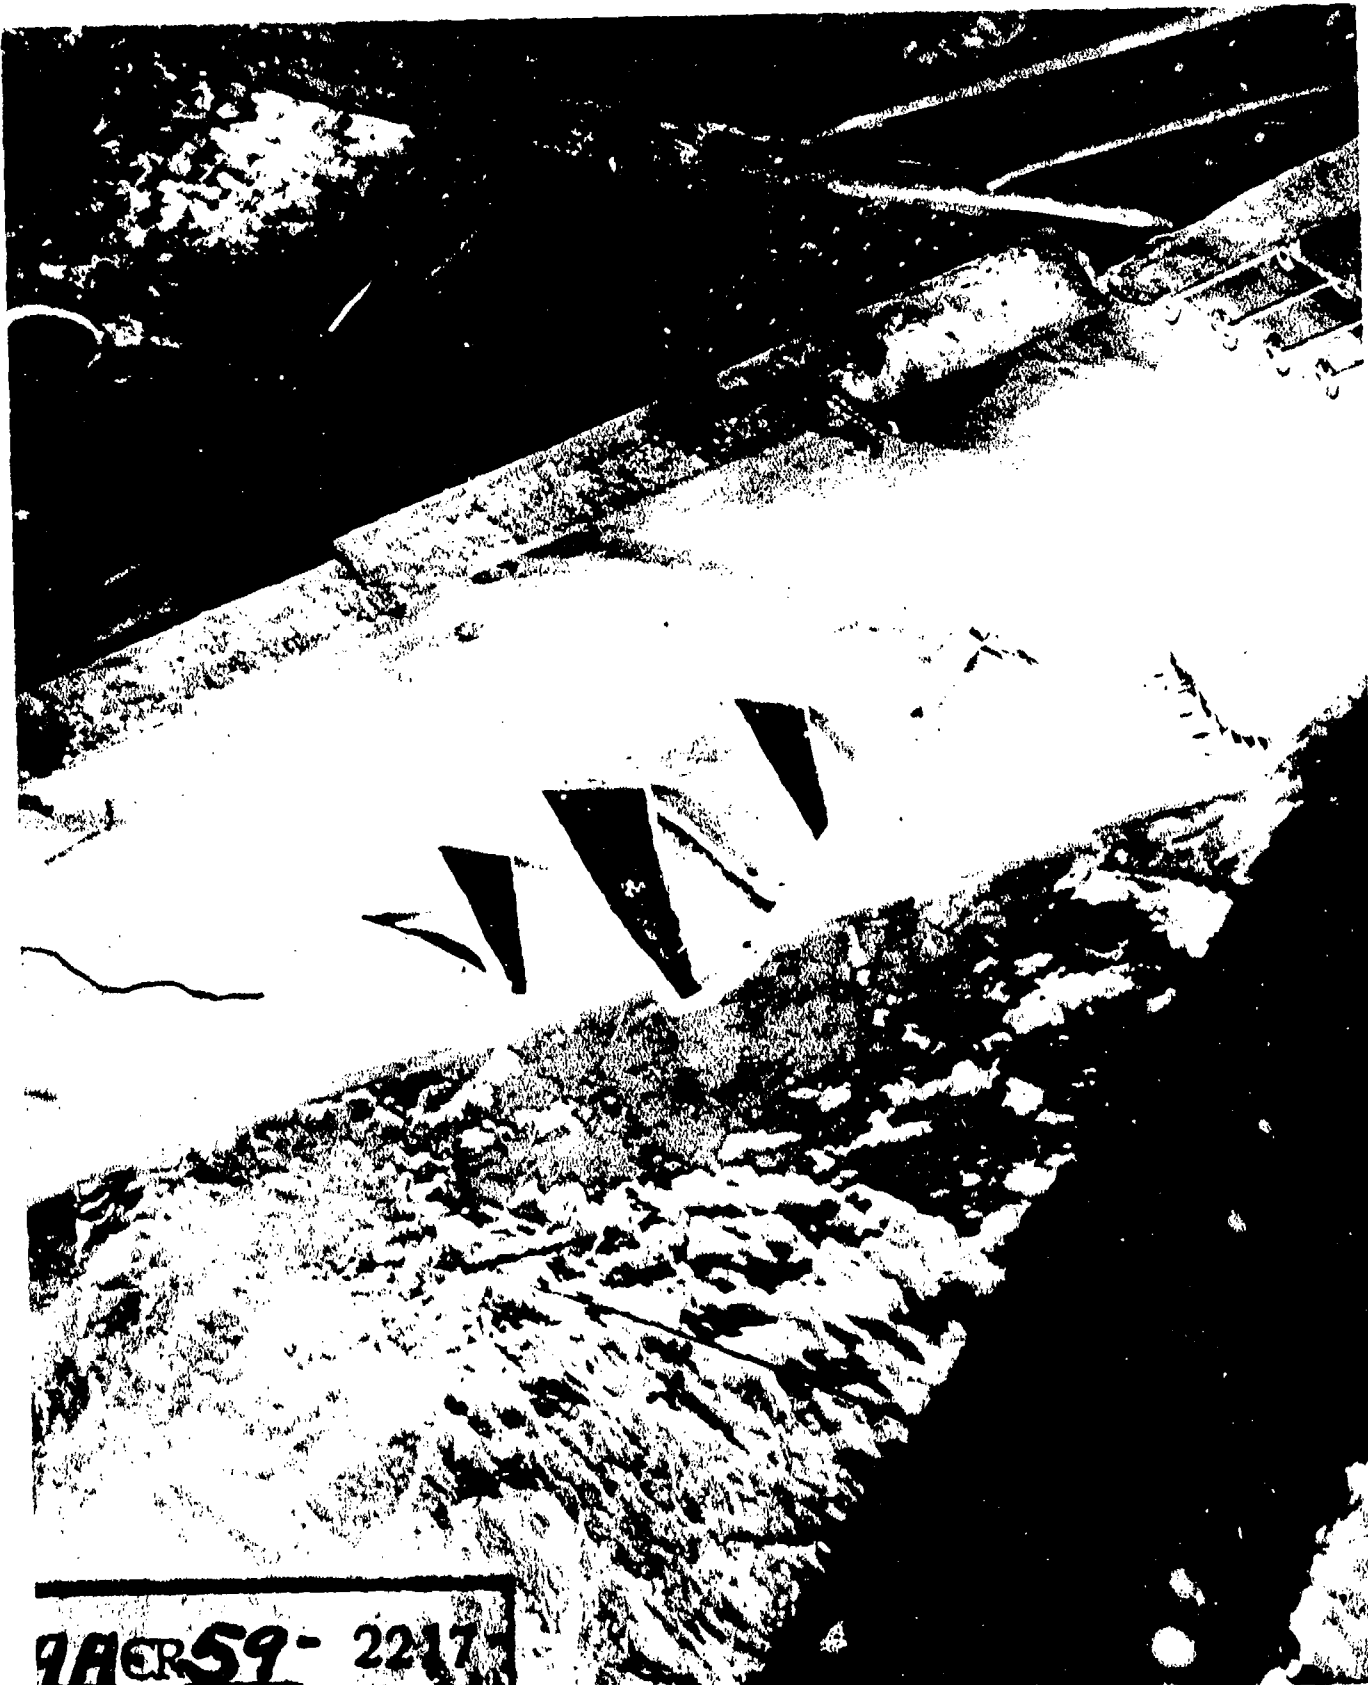
AA-CR-59-2217-4

AA-CR-59-2217-4. View looking down on port shell between frames 120 and 128. Propeller guards between frames 123 and 125.

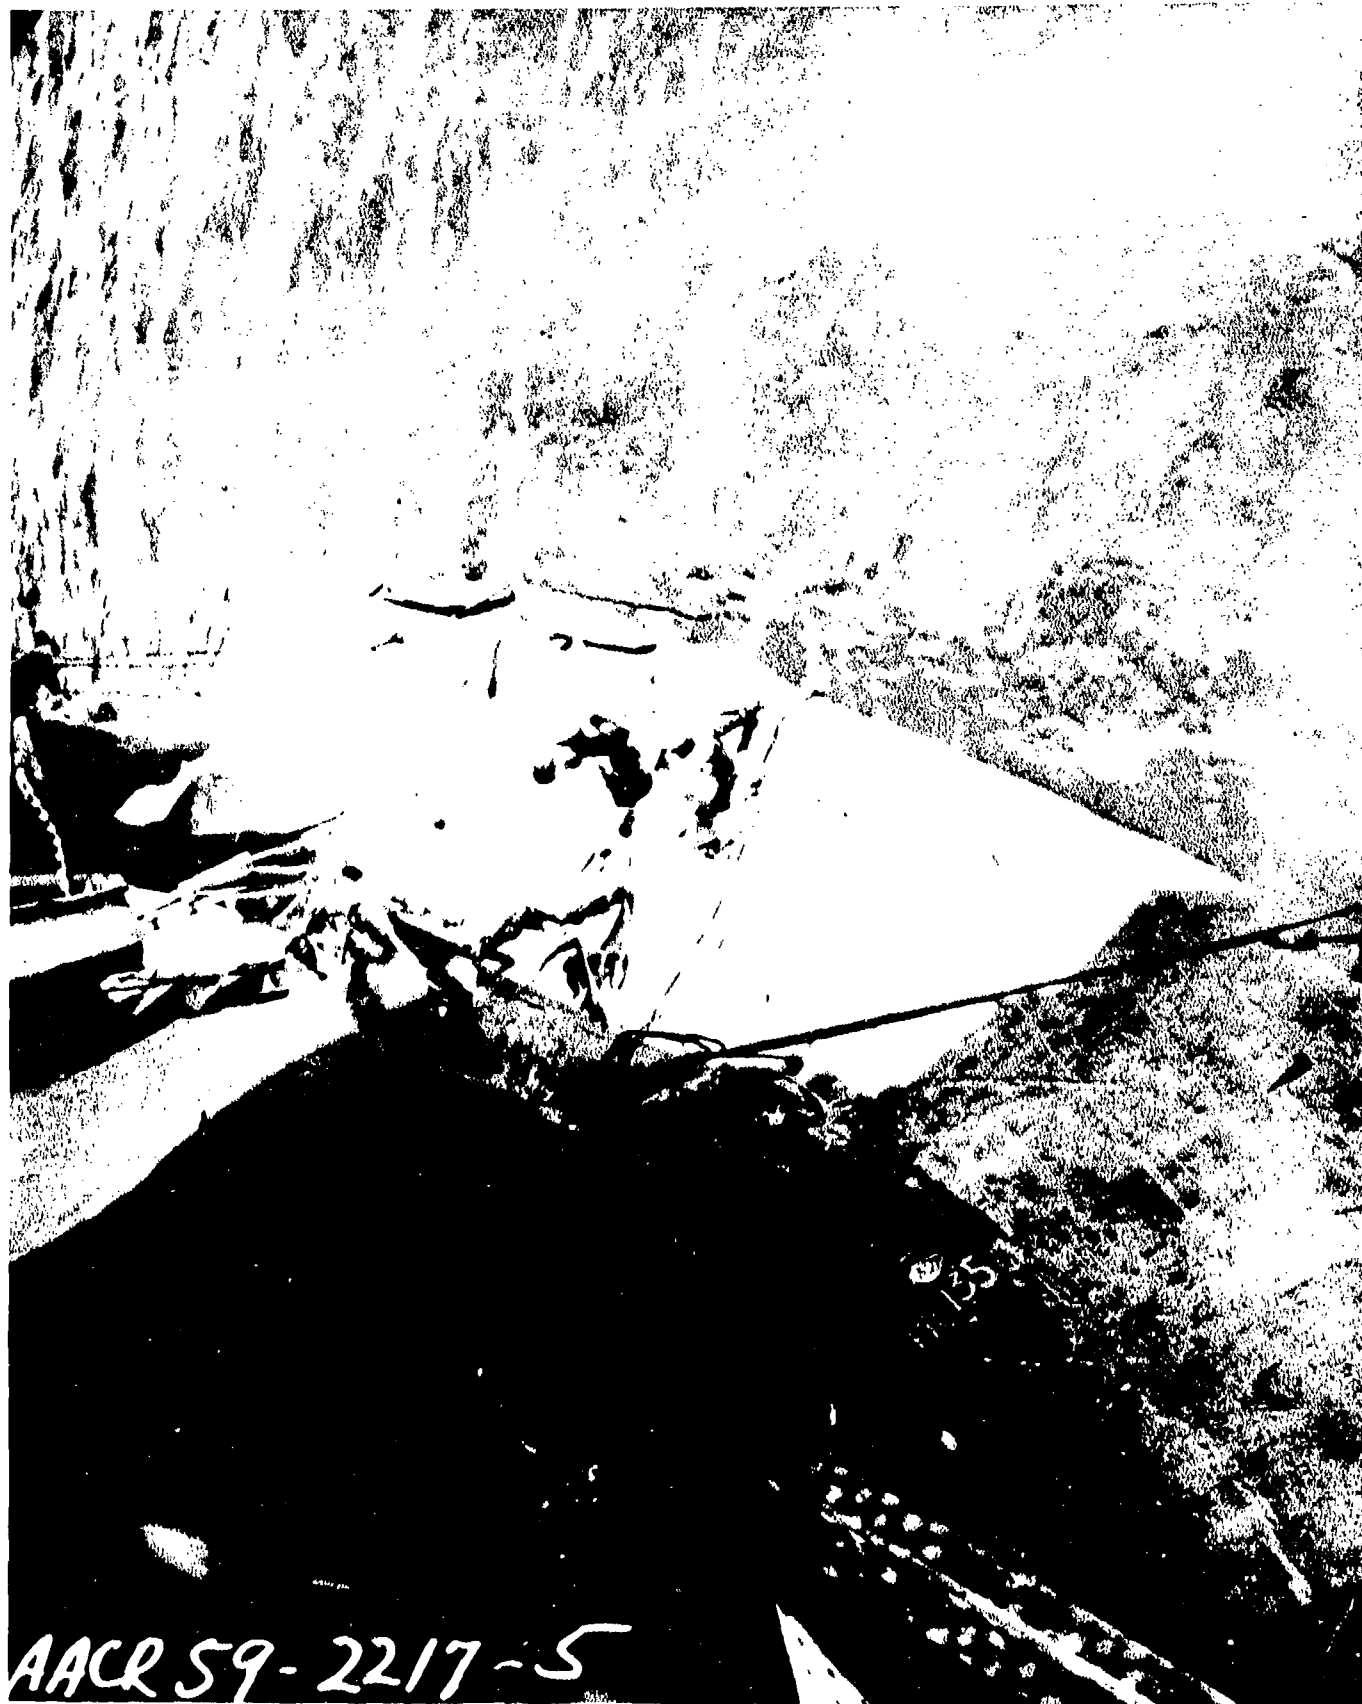
AA-CR-59-2217-5. Looking down on port side at third deck, aft of frame 132, from catwalk.
